Manhole Inspection Summary

Manhole # S43QQ_009MH

Location Address: **2619 AISQUITH ST**

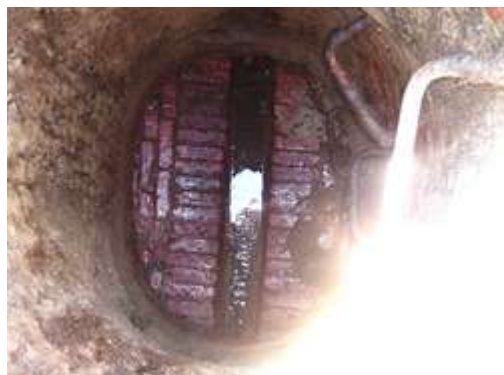
Top View

Corroded steps. Evidence of surcharge - Bench debris. Channel debris.

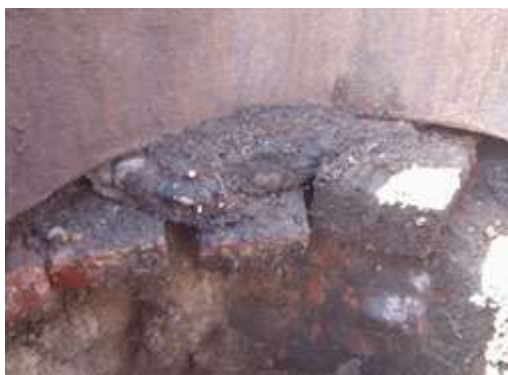
Defect

Frame leaks. Adjustment deterioration, loose brick and infiltration.

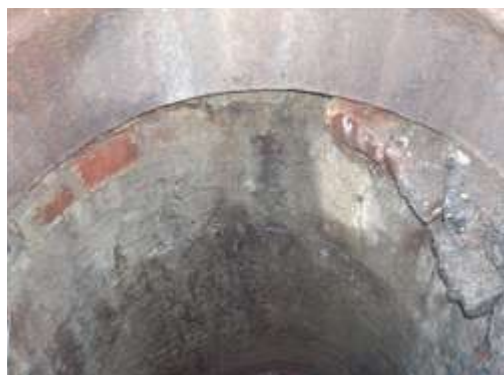
Defect

Frame leaks. Adjustment deterioration, loose brick and infiltration. Corbel infiltration.

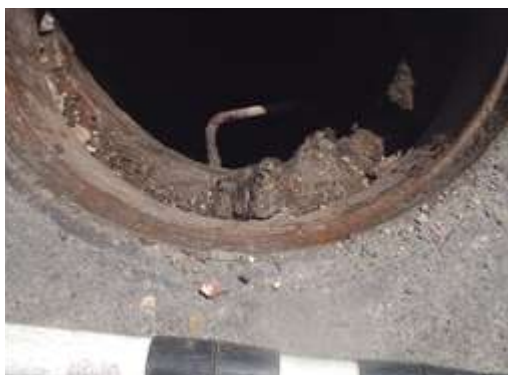
Defect

Frame leaks. Frame offset. Adjustment deterioration, loose brick and infiltration.

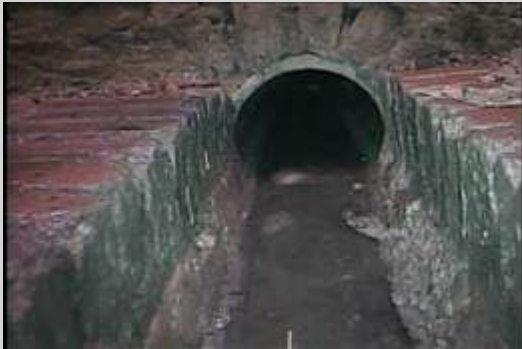
8 in. Circular Gravity Sewer Pipe Out @ 12 O'Clock

Deposits: ☐ None ☒ **Mud** ☐ Sludge ☒ **Debris** ☐ Grease

Silt Depth: **0.5** (in.) Deposits Extent: **Light**
